NARCAP International Air Safety Report 1
NARCAP IR-1, 2009

Near-Miss with UAP near Sao Paulo, Brazil Airport in 2004¹

Richard F. Haines

June 2009

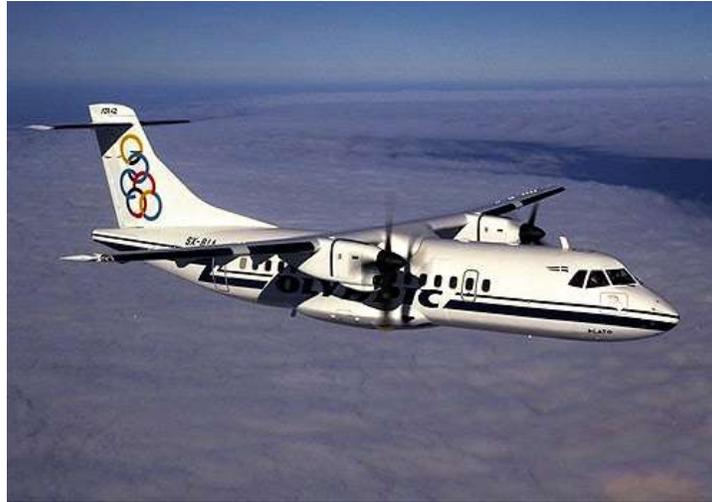
Figure 1
 ATR-42/300 In-flight
 aircat_FC_SaoPaulo_ATR42-500.jp

The pilots were flying a French built (Aerospatiale/ Alenia, Avions de Transport Regional) ATR-42-300, two-engine, short-haul, regional, turbo-prop aircraft. Figure 1 shows a similar model as flown by a different airline. This model aircraft has been in revenue service in many countries since 1985 with over four hundred built to date. The "42" refers to number of passengers. Its short take-off field length of 3,822 feet at sea level makes it an attractive aircraft for many locations. It is considered a relatively high performance aircraft. The latest version (ATR-42-500) has a maximum cruise speed at 17,000 feet = 300 kts; time to reach 17,000 feet from 1,500 feet = 9.9 minutes. The airplane involved here was not equipped with a Terminal Collision Avoidance System (TCAS).

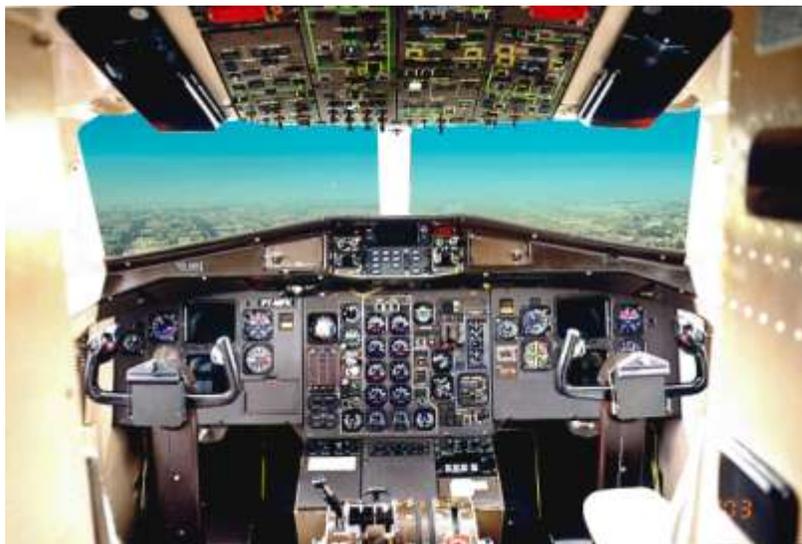
Figure 3
Approximate Location and Appearance of the UAP
when the Airplane was at Location A
aircat_FC_Sao_erik.jpg

In order to help visualize the apparent location of the UAP and its approximate angular size within the outline of the windshield the witness kindly provided several composite illustrations. He used cockpit photos he had taken (while on the ground) of the same model airplane; he stood just behind the pilots' seats on the cockpit's centerline. Then he superimposed other daytime aerial photos of the ground he had taken from the air at different locations. Figure 3 depicts the small, round, white UAP seen just left of the aircraft's center windshield post and low on the horizon when he was at location A (ERIC), basically straight ahead of them.

The witness' initial estimate of the distance to the UAP from location A was twenty nmiles. "... in the neighborhood of Sao Paulo airport (SBSP)." The measured distance from point A and airport SBGR is about 38.2 nmi.¹¹ The measured distance from point A to his destination airport, Congonhas Airport (SBSP) is about 33.5 nmiles. Of course the actual distance to the UAP is not known.

The witness also provided estimates of the angular size of the UAP at each of these three locations. At location A it appeared as "just another traffic (airplane) approaching them,"¹² "only as a single white light" (that) flew along a "constant course."¹³ He said its initial angular size was equivalent to about 1.5 times the thickness of a pencil lead or about 3 mm (d), the pencil held at arm's length. Assuming the viewing distance to the pencil to be 71 cm (D) the resulting angle ($\alpha^1 = \tan \alpha^1 = d/D$) or Tangent 0.00423. The resulting angle = about 14 minutes arc or just under one-half of the full Moon's diameter of 32 min. arc.

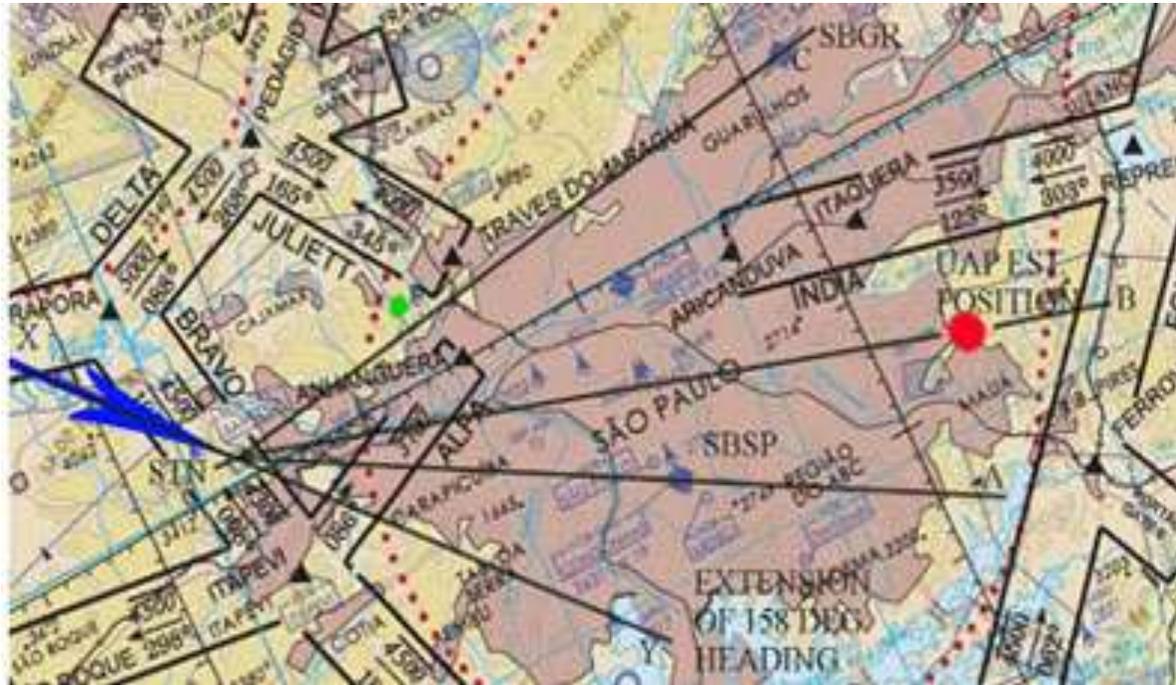
Figure 4
Sao Paulo Regional Chart
(Annotated points and lines explained in text)
aircat_FC_saopaulo_rfh1.jpg

Figure 4 has been prepared to help understand better the possible azimuth angles of different locations and the UAP as seen from location B.

Referring to Figure 4, the flight path of the airplane is shown by the diagonal blue arrow entering at the left-center.¹⁷ It points at the SANTANA VOR beacon (STN) but the line has been extended beyond (on heading of 158 deg.) to Y. This straight line is useful in measuring azimuth angles from the cockpit to various locations. Line STN - A is directed toward the Congonhas Airport (SBSP), some 17.3 nmi. away. Line STN - C is directed toward the Cumbica Airport (SBGR) about 23.8 nmi. away. Finally, the small red dot that represents the estimated location of the UAP (along the line STN - B) when first seen at location A. Its distance would have been about 29 nmiles away.

Assuming that the airplane was just approaching STN and had not yet begun its left turn, the UAP would have been located between 30 and 40 deg to their left side. However, if the UAP was not at the red dot location but somewhere else between Cumbica and Congonhas Airports then the UAP could have been between about 30 and 60 deg. arc to the left of their heading.

The author attempted to obtain a more accurate determination of the distance to the UAP as seen from location B. Using the chart presented in Figure 4 for basic ground reference points the

Referring to Figure 4, if the UAP was at the location marked by the witness (with a red dot) then: (1) its azimuthal location would have been somewhere between the two airports mentioned above, and (2) its distance (from point STN) would be about 28.8 nmiles. If the airplane were flying at about 165 kts (just beyond STN) and the UAP was 12 nmiles away at location B' (cf. Fig. 9) and both were on a direct collision course they would have met after 4.3 minutes of flight.

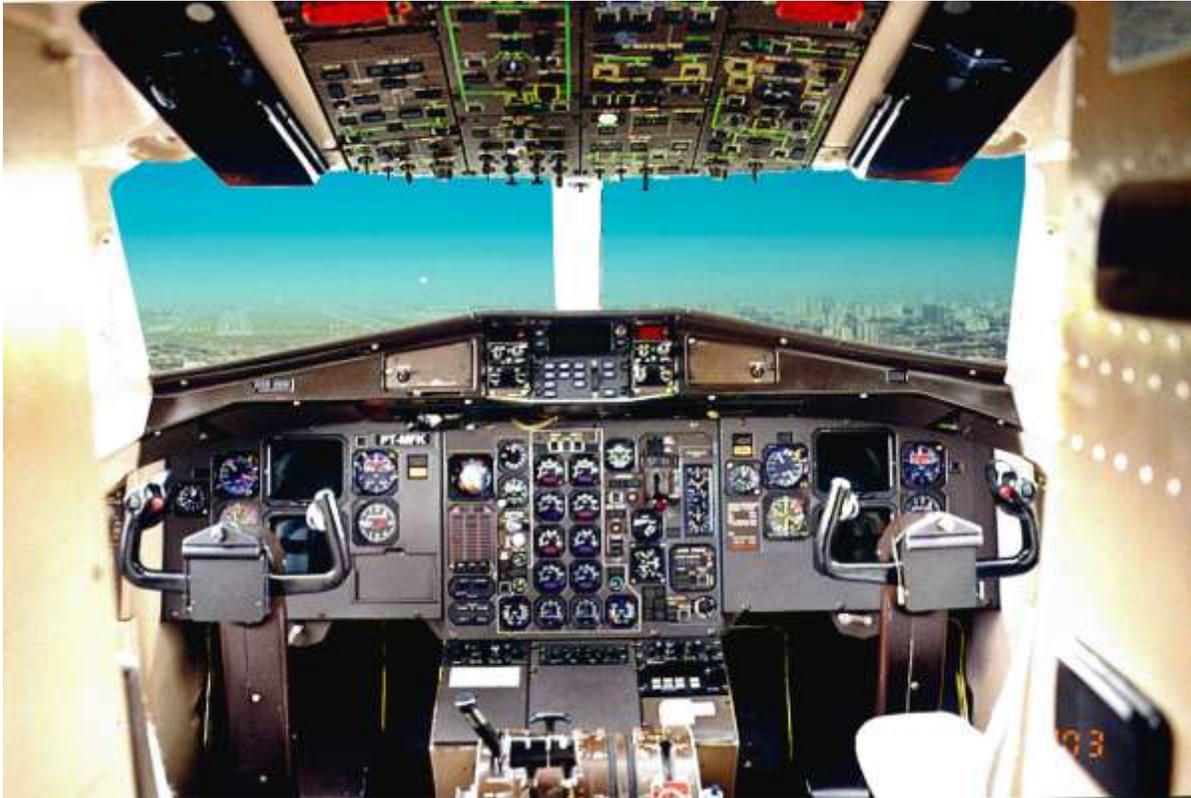
Figure 5
 Approximate Location and Appearance of
 the UAP when the Airplane was on a Heading
 of 106 Degrees at Location B
 aircat_FC_Sao_stn.jpg F-2 orig.

Figure 5 is the witness' photographic composite image of the UAP when the airplane was on a heading of 106 degrees and nearing a navigational fix indicated by **X** on Figure 8 but before beginning to turn right.

The reporting pilot said that the relative bearing to the UAP from the airplane²² was now only about six degrees to their right which confirms the pilot's stated concern that it might collide with them if the both continued their present flight paths.

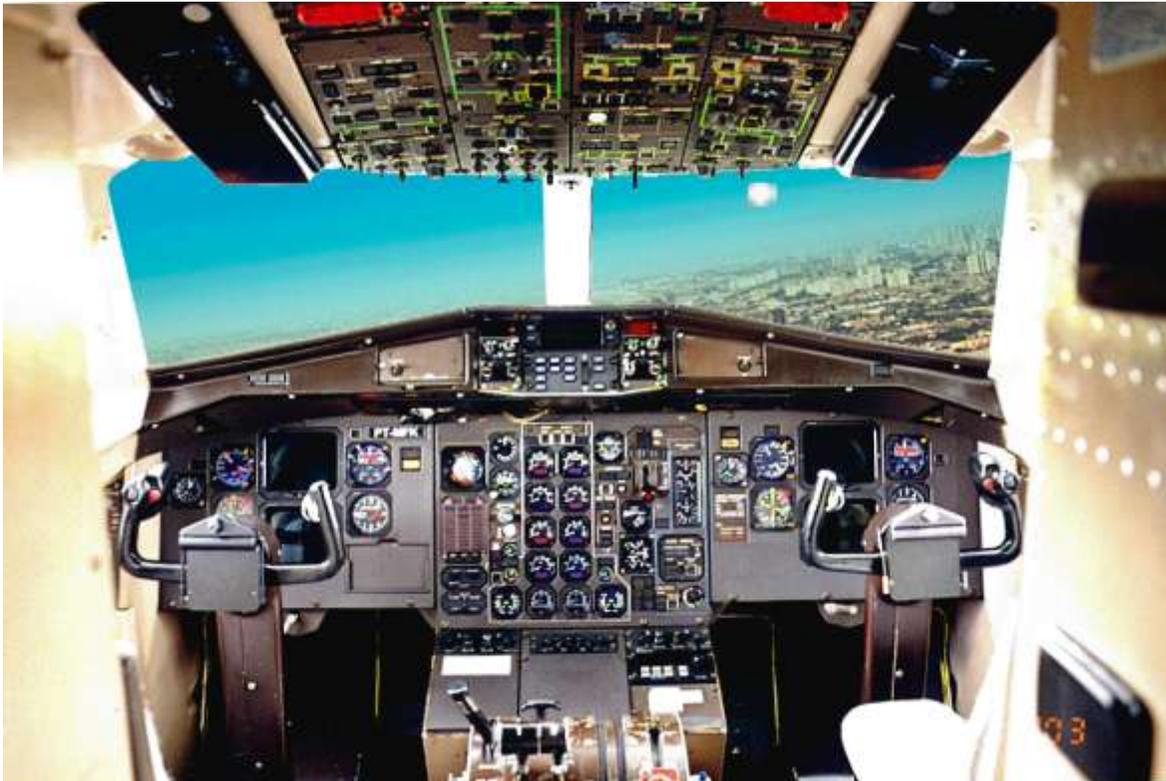
Figure 7
Approximate Location and Appearance of
the UAP when the Airplane was at Location C
at Beginning of Right-hand Banking Turn
aircat_FC_Sao_curve.jpg F-5 orig.

Then, when the airplane was "...very close to the interception point on the localizer," the UAP was now so close that Capt. XX decided to turn off the autopilot, bank sharply to the right, and descend slightly to "...avoid a collision." He wrote that he thought he did this about one minute's flight time before reaching the fix at EVER. This is portrayed by the witness in Figure 7.

At this point both crewmen saw "...a great torch of light (that) swept the cabin (and) caused great confusion. The cabin was suddenly and unexpectedly illuminated from the UAP appearing to come from the left side and moving across to the right. Both crewmen ducked down behind the instrument panel (for protection?) for several seconds, anticipating a mid-air collision. When I asked how long both crewmen bent forward and looked down the primary witness wrote, "Well, as soon as I initiated the curve (began to bank right and descend) perhaps in 2 seconds the beam came. I guess I would say about 8 seconds until the beam of light went away. ... Well, I was with the controls, having the object (so) close by and having to detour and fly the airplane. I think that when I (made) that decision, I started to look at him, like conveying, "you see what I am doing?" and immediately (the) light came around (and the) cockpit alert went high at that moment - and I saw him with his head bowed while the light passed, gazing at the (floor) and I guess he remained like that for the following seconds."²⁶

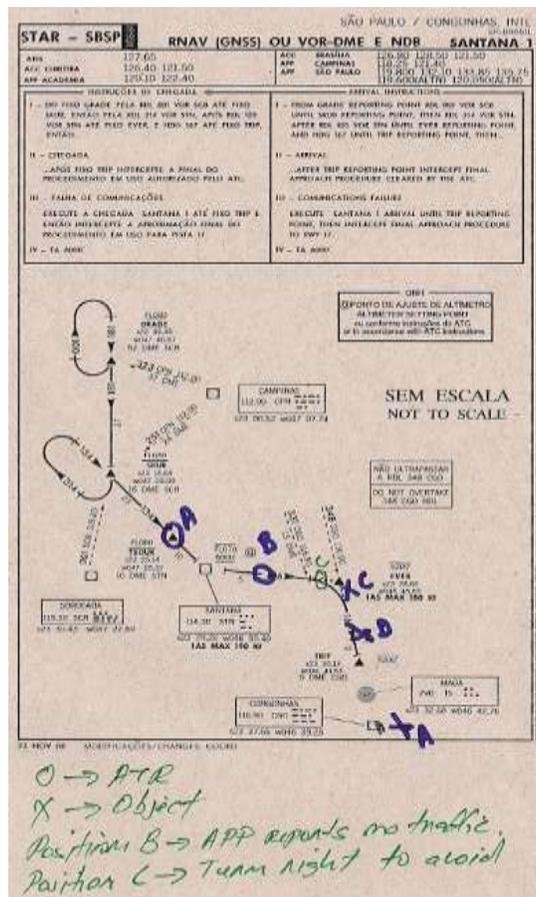
Figure 8
Annotated SANTANA 1 Approach Chart to Runway 17, Sao Paulo
(Original flight chart received with witness notations in blue ink)
aircat_FC_SaoPaulochart.jp

At this point it is necessary to consider another approach plate for Sao Paulo airport (SANTANA 1 Arrival) presented as Figure 8. This is the first approach chart the witness provided the author before he had more carefully reconsidered the flight path he had followed during the incident. He marked six locations in black pen on this chart.³¹ Circles labeled A, B, and C correspond to the three airplane locations discussed above. Crosses labeled A', B', and C' are the estimated positions of the UAP at corresponding times.

It is important to note that the apparent flight path of the UAP was linear and directed toward or near) the EVER navigational fix where the airplane also was headed. The UAP never appeared to veer toward the airplane; i.e., both were on a converging course. "By no means (did) the UAP move towards my path when I was (flying on a heading of) 106 deg before my detour."³²

It will be noted that the three positions of the airplane depicted in Figure 8 differ somewhat from those shown in Figure 2. This is because the witness subsequently remembered that he hadn't used the SANTANA 1 arrival chart during this event but, rather, the MADA arrival (i.e., Figure 2). Figure 8 is presented only for its depiction of the three UAP positions and their relative distances apart relative to the more accurately known position of the airplane at location A, B, and C; this helps establish durations between these three locations to a first order of accuracy. Table 1 presents the result of these calculations.

Note in Figure 8 that the UAP was drawn as traveling farther from A' to B' relative to the airplane's travel distance from A to B while the opposite is true between points B' and C' versus B and C. It is as if the UAP seemed to be approaching the intersection point at a higher rate of speed in order for it to cover the greater separation distances portrayed in Figure 2. This is made apparent in the calculated velocity values of the UAP in Table 1. Of course, if these marked UAP locations are not correct then this analysis is mute.

The reporting witness claimed that, as he originally sketched on Figure 8, the UAP appeared to be in the vicinity of the Congonhas Airport (SBSP) when first seen (location A'). Then the UAP moved continuously toward the NNW by about 4.7 miles over the same period of time as the airplane traversed from A to B or 5.7 minutes. This represents a UAP velocity of about 28 kts.

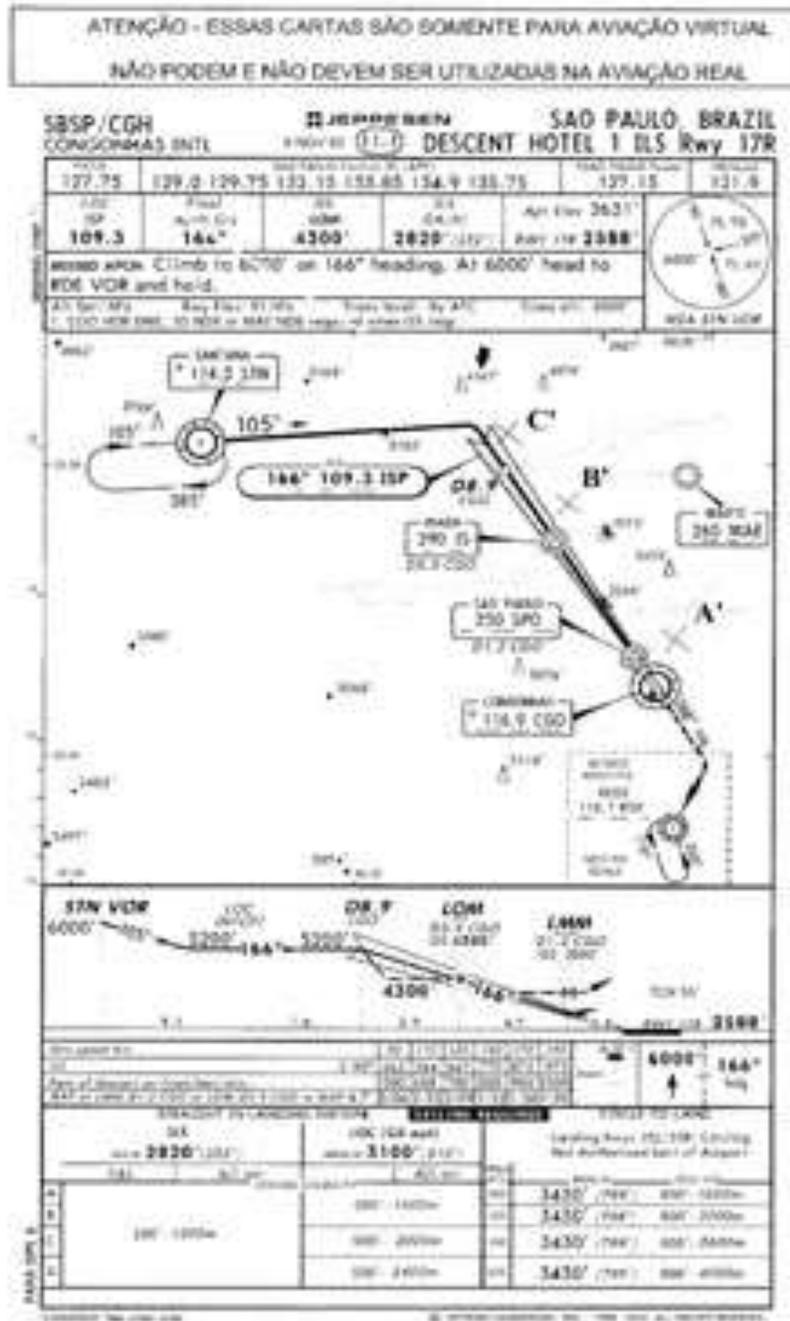
Figure 9
 Annotated Descent Hotel 1 Approach Chart to Runway 17, Sao Paulo
 aircat-FC_saoPaulohotel1_final1.jpg

For the sake of completeness and possible useful reference Figure 9 presents the DESCENT HOTEL 1 Approach chart to ILS Runway 17 to Sao Paulo. It contains much useful information for the region north and west of Congonhas International Airport (SBSP). This is an enlarged flight chart compared with Figure 2 and is useful for plotting the possible locations of the airplane and UAP relative to one another over time. Points C, A', B' and C' have been replotted according to the locations provided by the witness in Figure 8.

The lower diagram in Figure 9 shows an elevation view of the nominal ILS flight path that airplanes should follow to runway 17. Note that the localizer should be intercepted at an altitude of 5,200 feet and that there are several mountain peaks lying near the flight path making altitude control very critical. The outer marker should be crossed at 4,300 feet and the middle marker at decision height.
