Analysis of Digital Photographs of Commercial  
Airplane and Small UAP on November 8, 2009<sup>1</sup>

Richard F. Haines

November 27, 2009

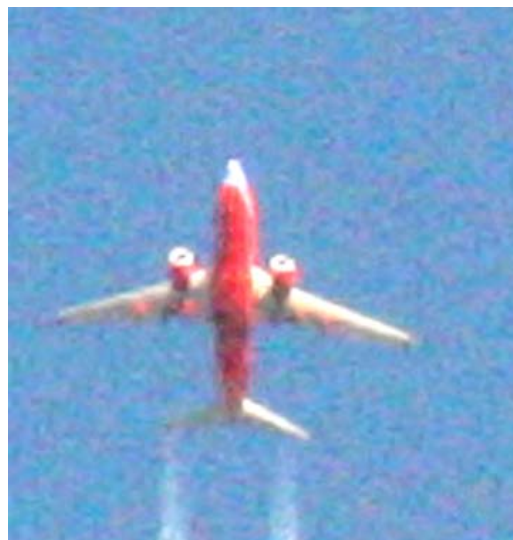
The first analysis consisted in enlarging the image of the jet airplane. Figure 1 shows it to be a B-737-300 (or later model) with the newer high-bypass engines. The width of its fuselage is 12.3 feet and the wingspan is 94.7 feet.

(IMG 0295) T = 17:16:37 1/500<sup>th</sup> sec. f8 250 mm

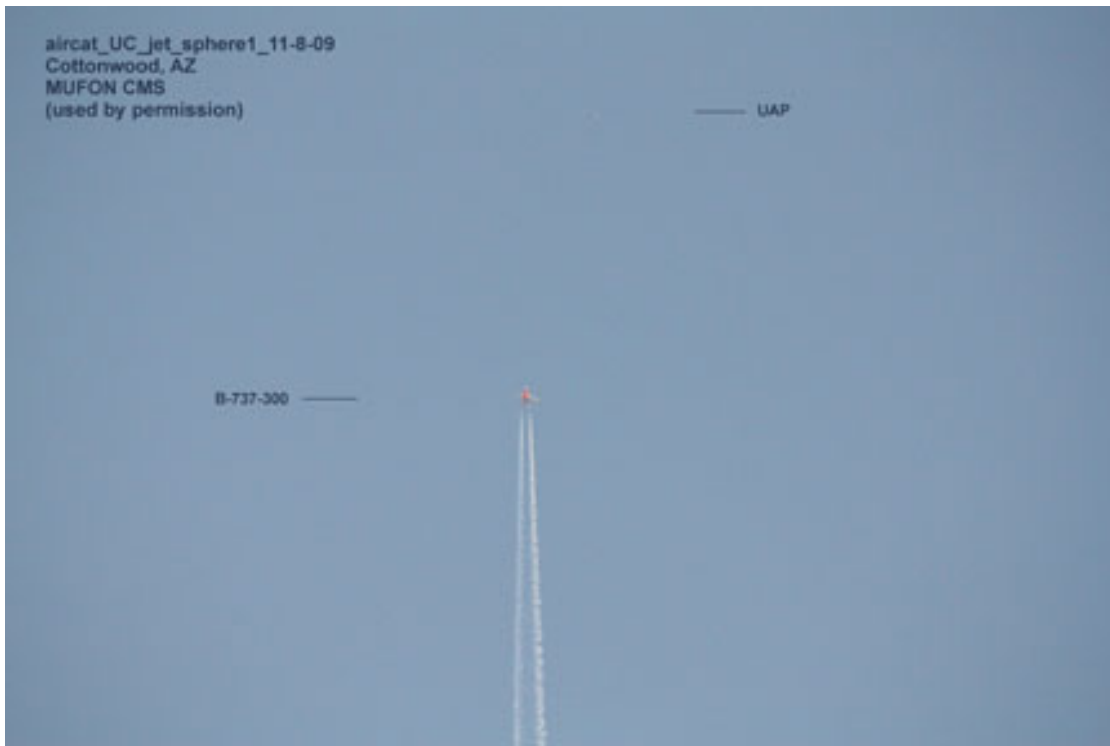
Figure 2

Photograph 1 of Commercial Airplane and UAP  
 In Front of Airplane on its Left Side  
 (IMG 0295) T = 17:16:37 1/500<sup>th</sup> sec. f8 250mm

Figures 2 and 3 are the first two digital color photos of Series I submitted to MUFON.<sup>7</sup> "T" represents local time for each photograph. Shutter speed and the aperture setting (f) is also given. He said he had already taken 180 photographs with this new camera before these UAP photographs in order to learn how to use its many functions.

The above estimated time intervals are useful in calculating the apparent velocity of the UAP. The first two photos (Figure 2 and 3) show the B-737 and provide a wingtip to wingtip linear dimension equivalent to a known distance of 94.75 feet. Table 1 provides measured and calculated values for the velocity of the UAP assuming that there was negligible horizontal movement of the contrail, i.e., it is assumed to be fixed in the sky for purposes of a first order approximation of UAP velocity and comparison with local winds (and thus possible balloon flight). Of course, local winds could have caused the contrail to drift toward the NE making a fixed point of light in the sky appear to move in the opposite direction. This possibility cannot be discounted.

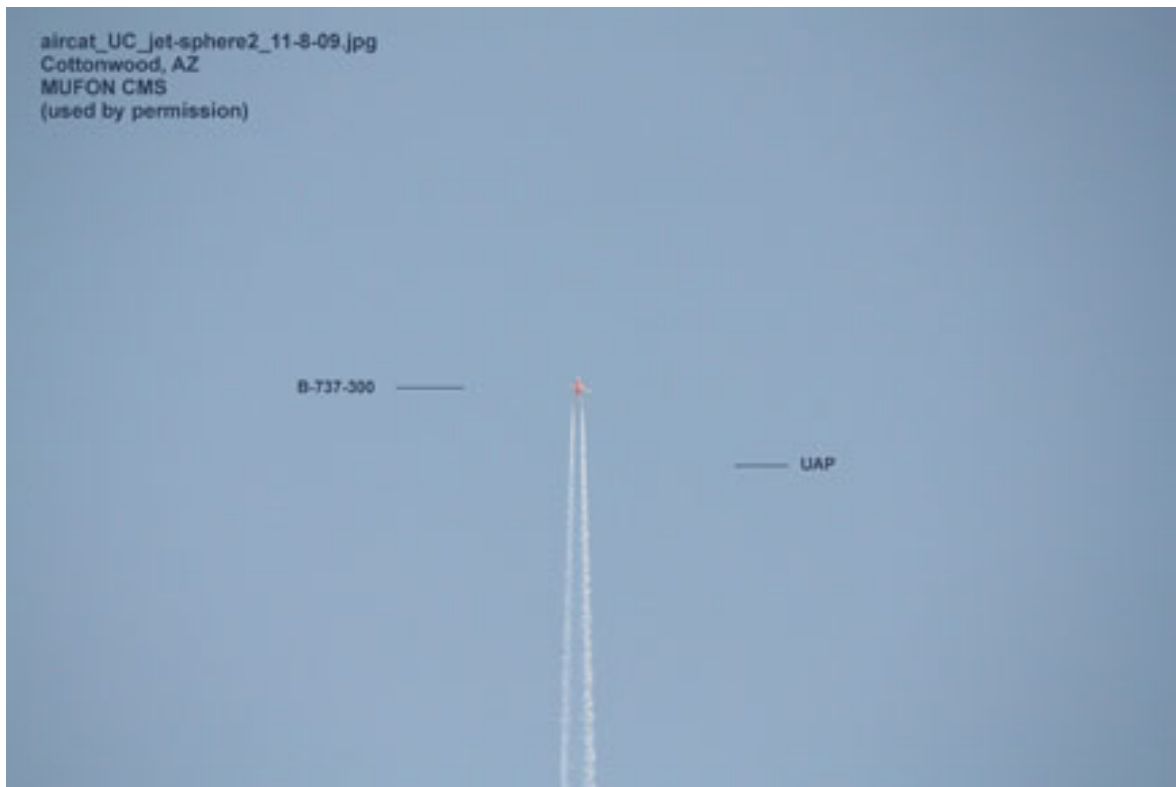
Figure 3  
 Photograph 2 of Commercial Airplane and UAP  
 Behind Airplane on its Left Side  
 (IMG 0296) T = 17:16:39 1/400<sup>th</sup> sec. f8 250 mm

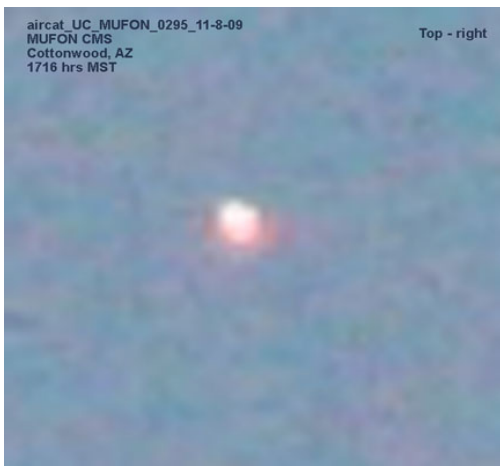
Figure 4

Enlarged UAP from Figure 1 (Series I)

IMG 0295 T = 17:16:37 1/500<sup>th</sup> sec. 250 mm

The second analysis performed consisted of enlarging only the UAP area on all of the twenty-one photographs. Several are reproduced here (Figures 4 through 13) at the same enlargement factor to illustrate the wide range of shapes that were recorded.

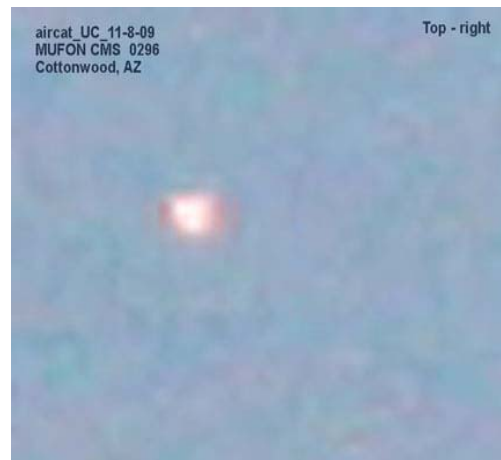
Figure 5

Enlarged UAP from Figure 2 (Series I)

IMG 0296 T = 17:16:39 1/400<sup>th</sup> sec. f8 250 mm

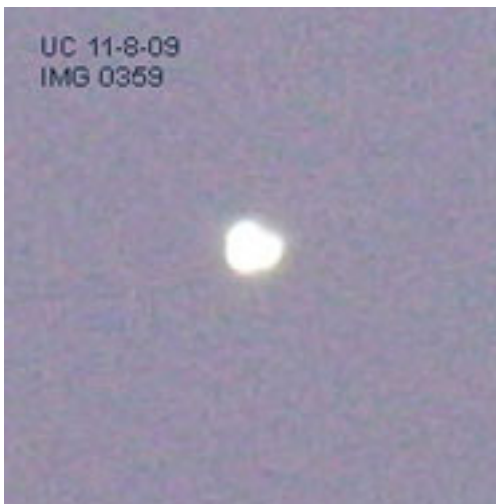
Enlarged UAP of IMG 0359 (Series I)

T = 17:46:38 1/8<sup>th</sup> sec. f5.6 250 mm

The total elapsed time of the eighteen images in Series II was 63 seconds<sup>14</sup> or 3.5 seconds per image on the average. Inspection of these images shows a wide variety of shapes, Figures 8, 10, 12, and 13 are generally symmetrical. The images in Series II raise interesting questions as to how they could have been produced within the brief shutter-open durations indicated. Given the similar shutter durations shown in Figure 11 and 12, for instance, how could the camera's image stabilization system have produced such different shapes only one second apart? The same could be asked about Figures 8 and 9. It is possible that the UAP was actually changing shape this fast. On the other hand, camera motion that exceeded the capability of the camera's image stabilization system might also possible explain these diverse shapes.

Even if three balloons were tethered together at their necks they could not assume the shape shown in Figure 8 (IMG 0359), but would appear something like that of Figure 18 in which all three spheres are distinctly outlined.

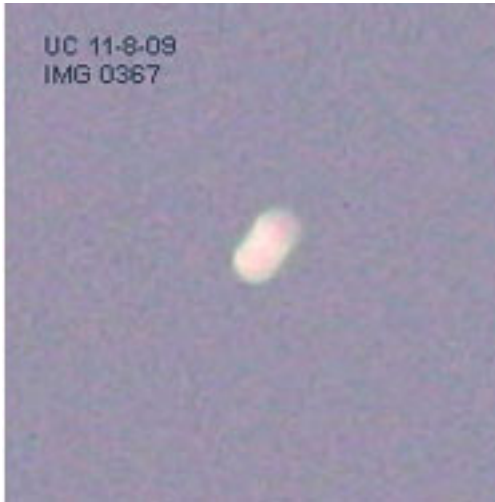
Figure 10

Enlarged UAP of IMG 0367 (Series II)

T = 17:47:06 1/15<sup>th</sup> sec. f4 65 mm

UAP size may only be compared between those photographs taken with the same zoom setting. Thus, IMG 0367 (Figure 10) through IMG 0374 (Figure 13) were taken with the zoom pulled back significantly from 250 mm which would cause the UAP to shrink in size.

Image 0367 (Figure 10) is interesting because the interior of the UAP possesses a slight reddish color; all of the other photographs were intense white which suggests an overexposure

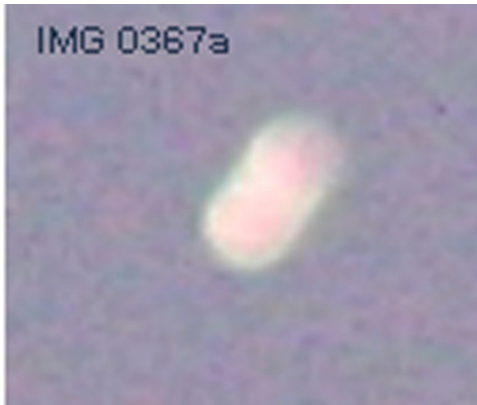
Figure 14  
Image 0367 - Enlarged

condition. Figure 14 presents the original image enlarged. In Figure 15 the three input

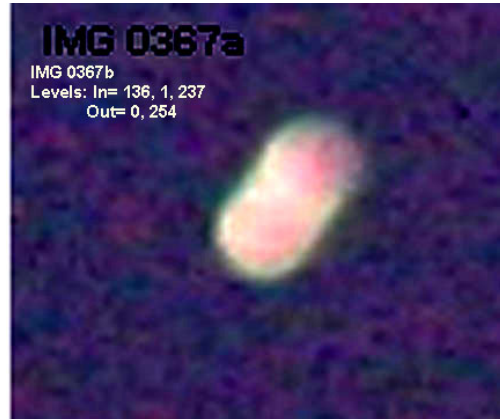
Figure 15  
Image 0367 - Exposure Stretched

levels (0, 1, 255) were reduced to 136, 1, and 237 (exposure) bits while the output was not changed (1, 255). This procedure helps to make luminance differences within the UAP more apparent. Figure 16 shows the results of increasing contrast and decreasing brightness; there appears to be two round, red balls inside the overall shape of this UAP. The fact that no internal colors could be seen on any other photograph (other than an intense homogeneous white) suggests that the luminous output of the UAP was so great that it exceeded the camera's CCD maximum sensitivity and only IMG 0367 showed the UAP at a lower radiated output level.

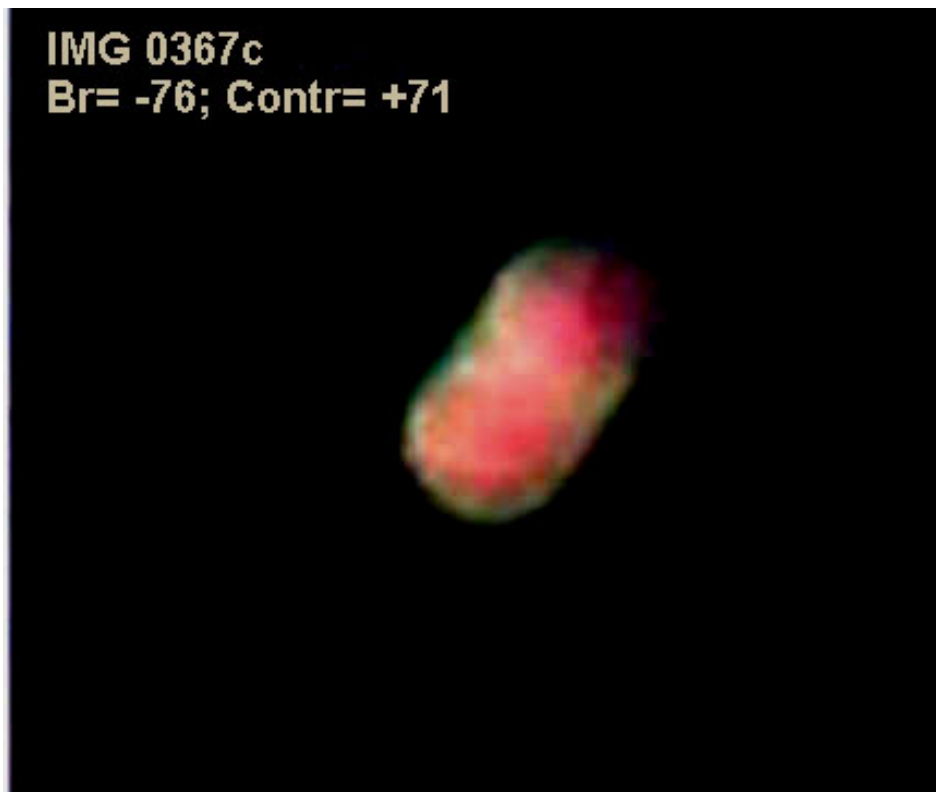
Figure 16  
Image 0367 - Contrast/Brightness Change

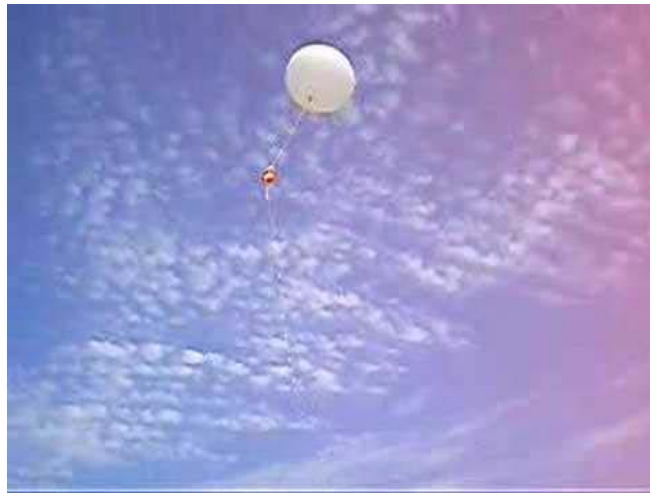
Figure 17  
 NOAA Weather Balloon Soon after Launch  
 (Courtesy of NOAA)

Flagstaff, Phoenix, and Tucson, Arizona twice a day twelve hours apart at 0400 hrs and 1600 hrs local time (MST) (Figure 17). Assuming they are about six feet diameter at ground level,
